LIGONIER DAM

NDI No. PA 00477
PennDER No. 65-117

PHASE I INSPECTION REPORT
NATIONAL DAM INSPECTION PROGRAM

March 1980

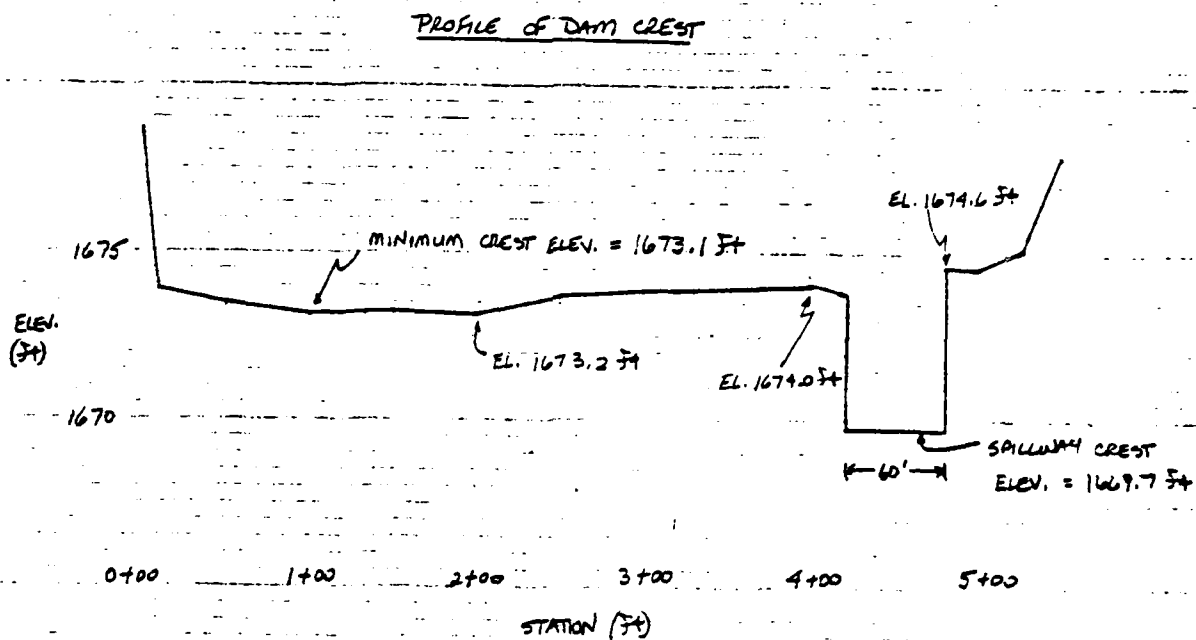
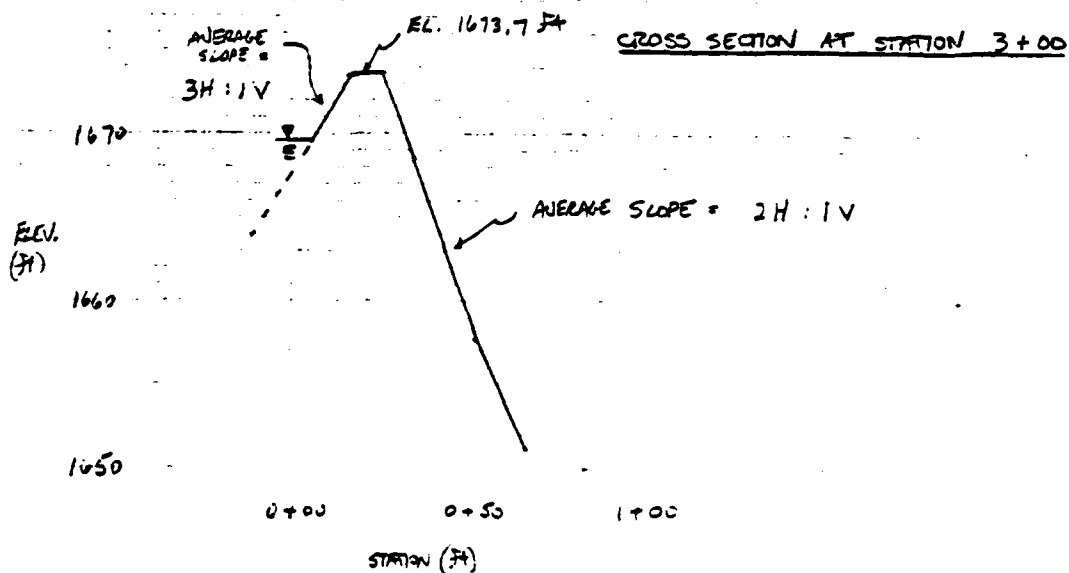
LIGONIER DAM
TOP OF DAM PROFILE
TYPICAL CROSS-SECTION

- 2) The average top of dam elevation, as surveyed during the field inspection, is approximately 1673.8 feet M.S.L. Design plans indicate that the top of dam elevation was intended to be 1674.5 feet M.S.L. Only the right 50 feet of the embankment is currently at the design elevation. It was noted in one of the progress reports that the placement of topsoiling and seeding the embankment was deleted from the contractor's work. These items were to be completed by the authority. It is doubtful that the topsoil was placed.

VISUAL EXAMINATION OF	OBSERVATIONS	REMARKS OR RECOMMENDATIONS
VERTICAL AND HORIZONTAL ALIGNMENT OF THE CREST	Visual inspection of the horizontal alignment indicated no problems. The top of dam profile (Appendix D) shows that the left section of the embankment is low. Elevations of the dam crest range from 1674.5 ft. M.S.L. on the right side of the embankment to a minimum of 1673.1 ft. M.S.L. at Station 1+00.	The top of dam elevation should be restored to the original design Elevation of 1674.5 ft. M.S.L.

- 3) It is recommended that the dam be raised to the original design elevation of 1674.5 feet M.S.L.
- 4) The seepage area previously noted should continue to be examined in the future and the condition recorded. Should future inspections disclose that the quantity or encroachment on the downstream face has increased and/or turbidity is observed in the seepage, then further evaluations and corrective measures may become necessary to protect the structural stability of the embankment.
